THE STRAWBERRY CREEK AND PYRAMID GUARD STATION LANDSLIDES

A Thesis

Steven Francis Connelly

June 1988

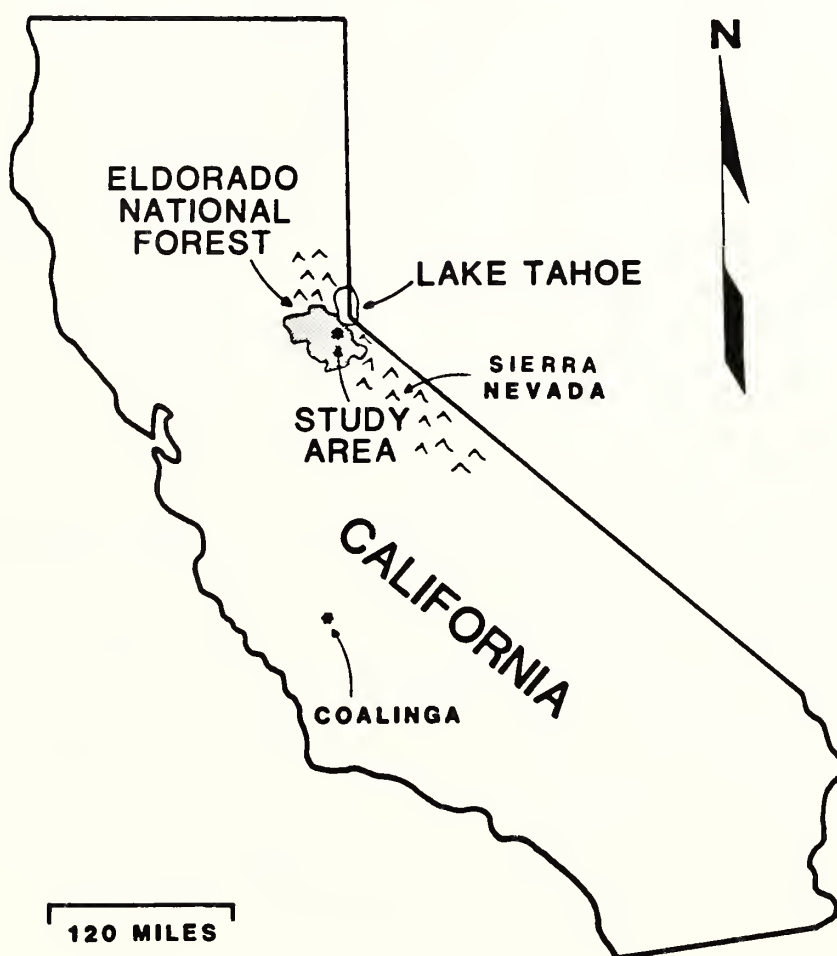
Figure 1. Regional location map.

The Strawberry Creek and Pyramid Guard Station landslides are in the Eldorado National Forest, southwest of Lake Tahoe, California (Fig. 1). U.S. Highway 50 transects the Eldorado National Forest in a northwest direction. The crest of the Sierra Nevada mountain range

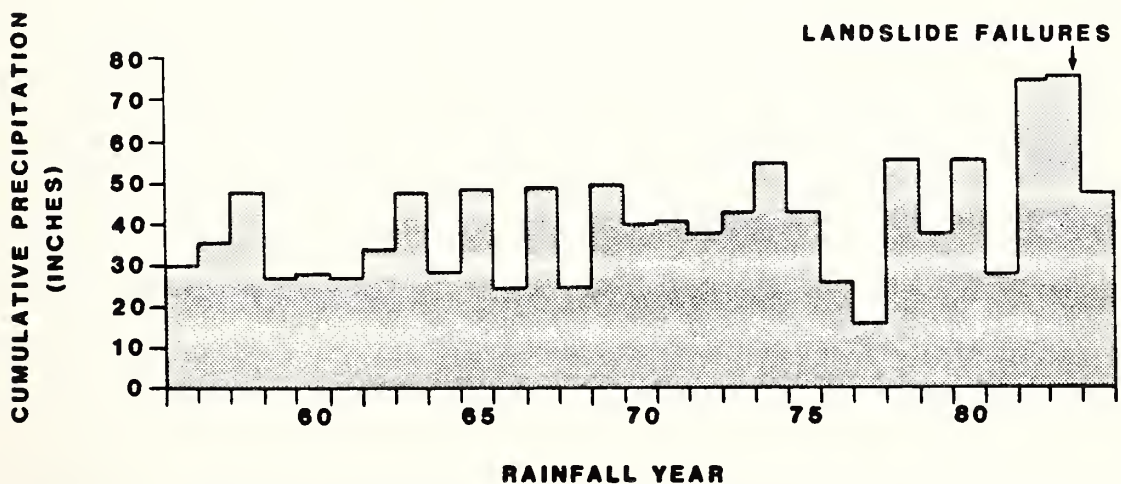
Figure 5. Cumulative yearly precipitation measured at Kyburz, California (Pacific Gas & Electric Company, 1985).

Precipitation and temperature data have been collected by the Pacific Gas & Electric Company (1985) at a power intake along the South Fork of the American River near Kyburz, California. Kyburz is located about 8 miles west of Strawberry at an elevation of approximately 4,000 feet. A graph of cumulative yearly precipitation (rainfall and equivalent snowfall) recorded at Kyburz is presented in Figure 5 for

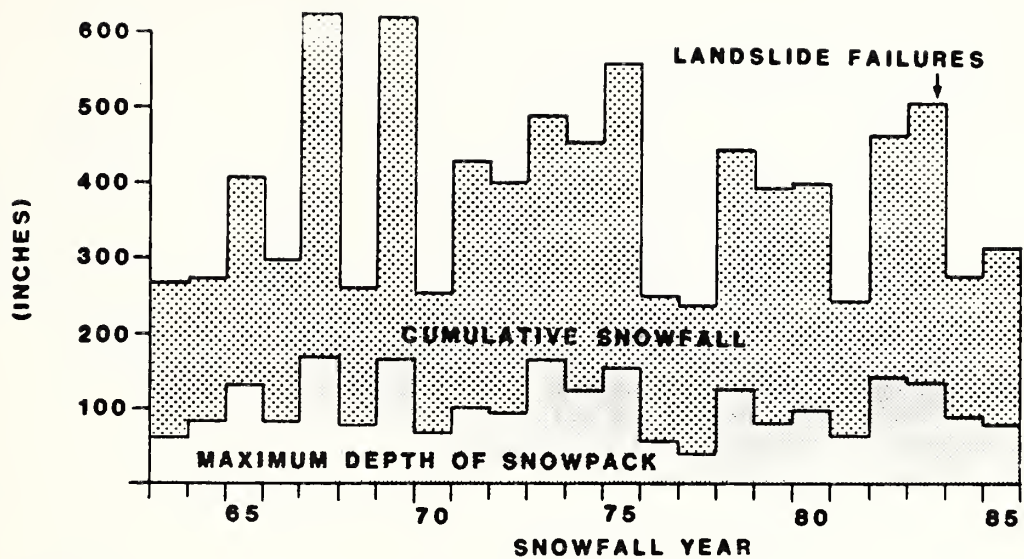
Figure 6. Cumulative seasonal snowfall and maximum seasonal snowpack measured at Echo Summit, California (California Department of Transportation, 1985).

Snowfall and snowpack measurements have been collected by the California Department of Transportation (1985) at Echo Summit, California. Echo Summit is located approximately 7 miles east of the study area (Fig. 2) at an elevation of approximately 7,400 feet (similar to the elevations of the source areas of the subject landslides). A graph showing the cumulative seasonal snowfall and maximum seasonal snowpack recorded at Echo Summit between 1963 and 1985 is presented in Figure 6. During the 1983 season, Echo Summit received 132 percent of the average total seasonal snowfall and 127 percent of the average maximum seasonal snowpack for the 23 year time period.

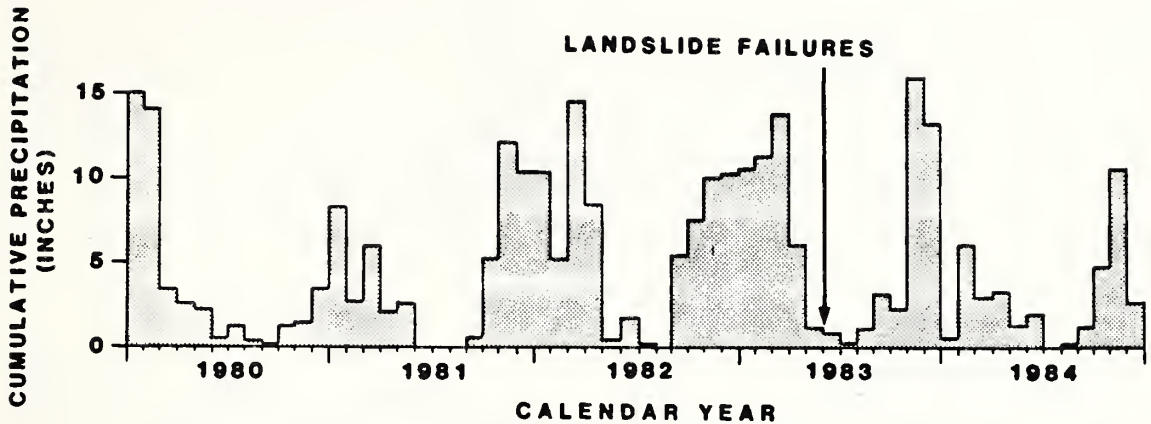
Figure 7. Cumulative monthly precipitation measured at Kyburz, California (Pacific Gas & Electric Company, 1985).

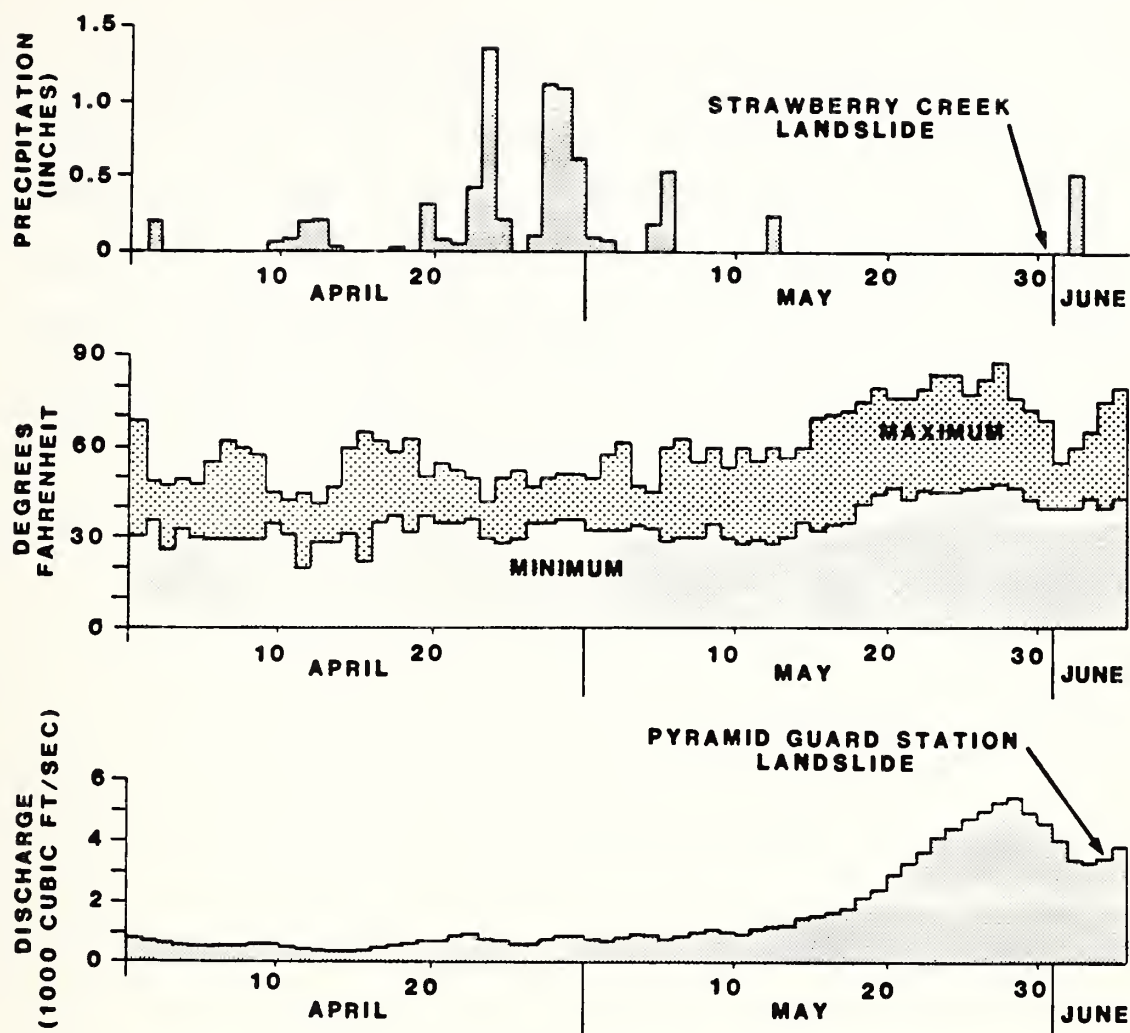
Figure 8. Daily precipitation (Pacific Gas & Electric Company, 1985), maximum and minimum temperatures (Sacramento Municipal Utilities District, 1983), and stream discharge levels (P. G. & E., 1985) for April through early June, 1983 (precipitation and stream discharge data collected at Kyburz, temperature data collected at Alpha site).

A two-week-long heatwave, starting on May 17 and ending on about May 31, immediately preceded the failures of the subject landslides. An average daily maximum temperature of 58 degrees Fahrenheit and an average daily minimum temperature of 42 degrees Fahrenheit were measured at Alpha site during the heatwave. A peak temperature recorded during the heatwave of 67 degrees Fahrenheit occurred on May 26. Approximately 1 inch of rainfall was recorded at Kyburz during the first two weeks of May and no precipitation was recorded during the heatwave. About 1/2 inch of rainfall was measured at Kyburz on June 2.

An oblique aerial photograph taken about two weeks after the Strawberry Creek landslide event is shown in Figure 16. The photograph indicates that the snowline was very close to the source area of the landslide at the time of its failure. This snow level evidence, supported by temperature and stream level data presented in Figure 8,

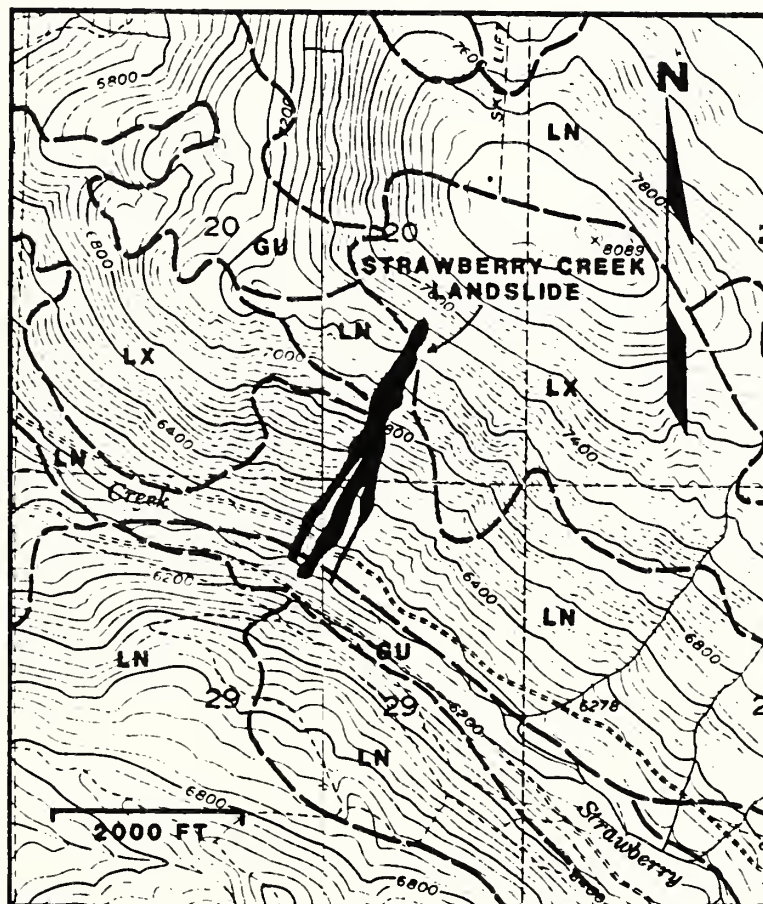
Soils Key: LX - Lithic Xerumbrepts-Rock outcrop complex  
 LN - Ledford-Notned complex  
 GU - Gerle-Umbrepts association

The soils on the lower section of the slope in the landslide vicinity are classified as Ledford-Notned complex, derived from weathered granitic rocks. A grain size distribution curve for sample 1, of Ledford-Notned soil, is presented in Appendix B, Graph 1. The Ledford-Notned complex soils are deep to very deep with weathered granitic bedrock typically occurring at depths between 40 and 60 inches. The soils are well drained to excessively drained, soil permeability is rapid to very rapid, and the maximum erosion hazard of the soil is moderate to high.

The soils at the base of the slope near Strawberry Creek are classified as Gerle-Umbrepts association, derived from weathered glacial till, glacial outwash, and alluvium composed primarily of granitic rock. The Gerle soils are deep, typically developed 40 to 60 inches below the ground surface. The soils are well drained, soil permeability is moderately rapid, and the maximum erosion hazard of the soil is moderate.

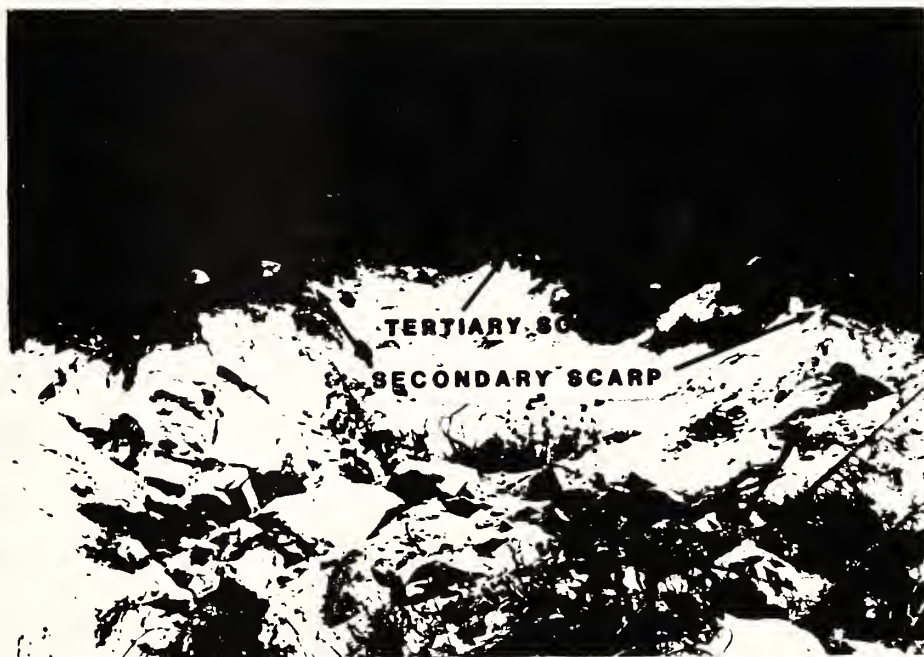
Figure 11. Secondary and tertiary scarps in the crown of the Strawberry Creek landslide. Mound of debris derived from the secondary and tertiary failures is evident in foreground.

A large mound of debris containing fractured boulders, trees, and brush overlies the initial rupture surface (Fig. 11). The debris was derived from the secondary and tertiary failures, upslope from the initial failure.

The secondary scarp is marked by arcuate-shaped tension cracks in the ground surface, located at both sides of the landslide scarp at an elevation of approximately 7,450 feet. The margins of the scarp narrow significantly from an elevation of 7,400 to 7,450 feet. The tertiary scarp, which forms the crown of the landslide, is flanked by tension cracks at its margins. A large tension crack extends about 120 feet

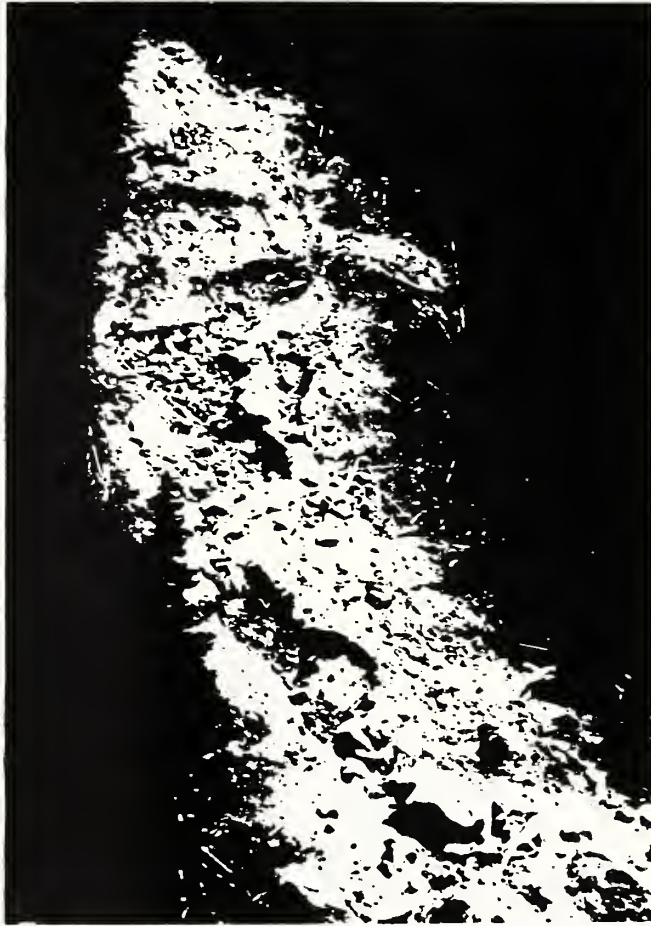
Figure 12. Aerial photograph of the upper main channel of the Strawberry Creek landslide. Brown debris-flow deposit containing abundant fallen trees is evident at margins of landslide. Gray debris-flow deposit evident within the interior of the landslide contains large boulders and gullies. The large boulder in the foreground is 22 feet in diameter.

Two distinct deposits were laid down by the Strawberry Creek landslide: a brown debris-flow deposit associated with the initial failure, and a gray debris-flow deposit associated with the secondary and tertiary failures (Fig. 12). Exposures of brown debris-flow

Stream action subsequent to the landslide event has created extensive gullies on the landslide surface, as evident on Figure 12. Water draining from the landslide has cut steep, v-shaped gullies through the debris-flow deposits, the underlying colluvium, and the weathered bedrock material to depths as much as 20 feet below the original landslide surface.

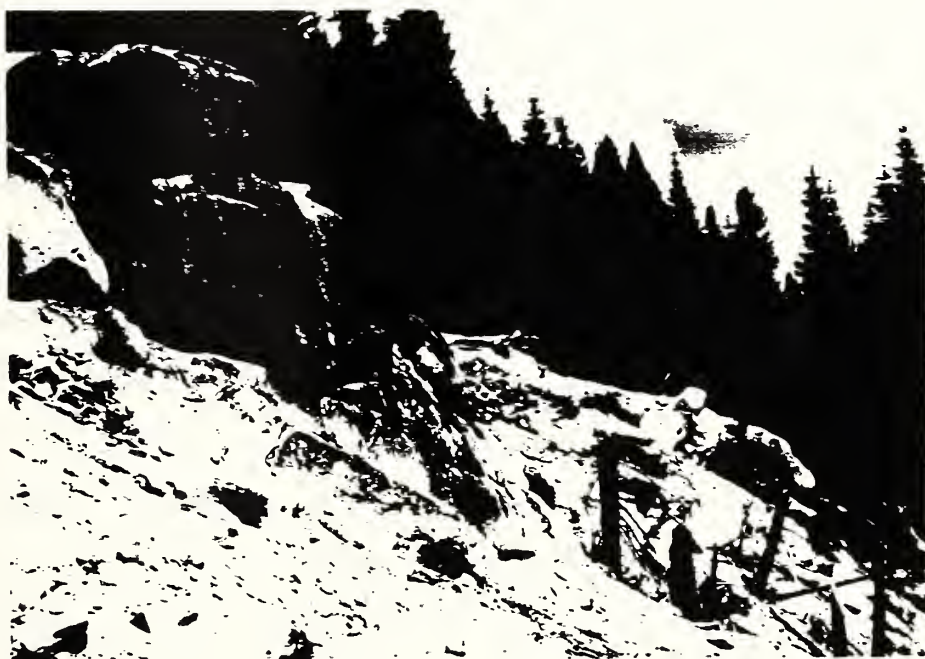
Figure 13. Rock outcrop located within the center of the landslide channel. The debris flow became airborne as it passed over the outcrop and sheared off the tree tops below. Tree stumps are still rooted below the rock outcrop.

A rock outcrop of granodiorite (Fig. 13) is located in the center of the upper debris-flow channel at an elevation of approximately 6,960 feet. In general, the landslide uprooted every tree in its path, but below this rock outcrop several trees are still rooted in place. The trunks of the trees, however, are sheared off a few feet above their bases. The landslide mass was evidently travelling at a speed sufficient for the debris to become airborne as it flowed over the rock outcrop, snapping the tops of the trees off, while leaving their trunks firmly rooted.

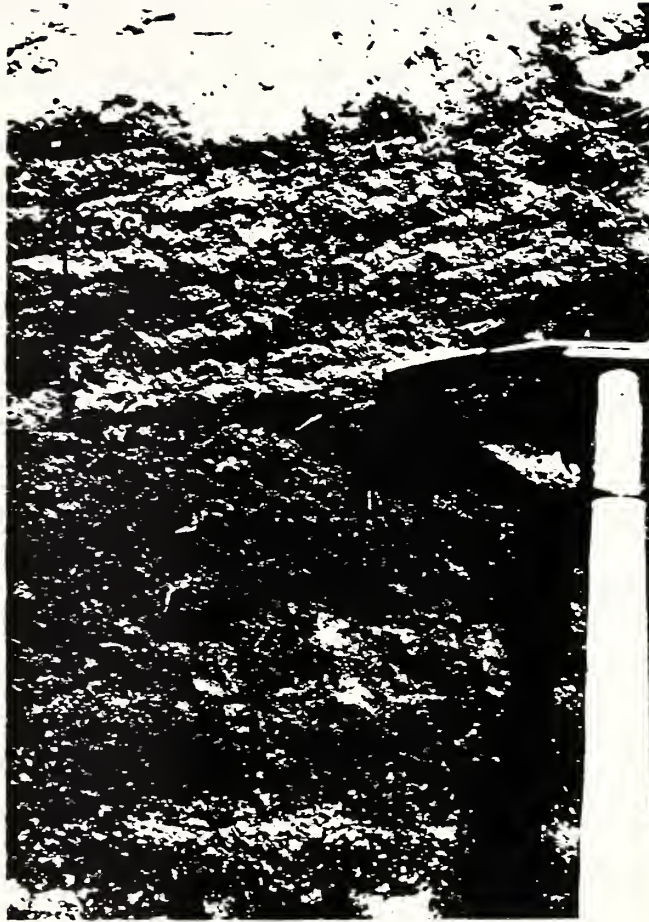
Figure 14. Relationships between gray debris-flow deposit (GDF), brown debris-flow deposit (BDF), and colluvium (COL) exposed on pit wall. Pick head points to contact between gray and brown debris-flow deposits.

relationship between the two deposits is illustrated in Figure 14, which shows a wall of the pit. The pick head points to the base of the gray debris-flow deposit which overlies brown debris-flow deposit. The brown debris-flow deposit rests upon a surface scoured on top of colluvial material, which is stained red from oxidation. Preexisting topsoil material on top of the colluvium had been removed by the erosive,

initial, debris-flow front as it travelled downslope. The relationships observed in the pit clearly indicate that the brown debris-flow deposit was laid down and subsequently covered by the gray debris-flow deposit.

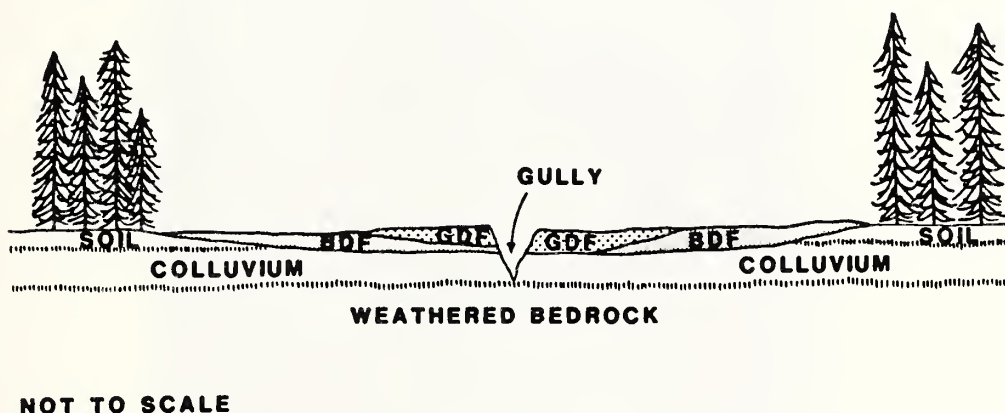
Figure 15. Schematic cross-section of the central Strawberry Creek landslide channel, perpendicular to flow direction, depicting the relationships of the brown and gray debris-flow deposits (BDF and GDF, respectively).

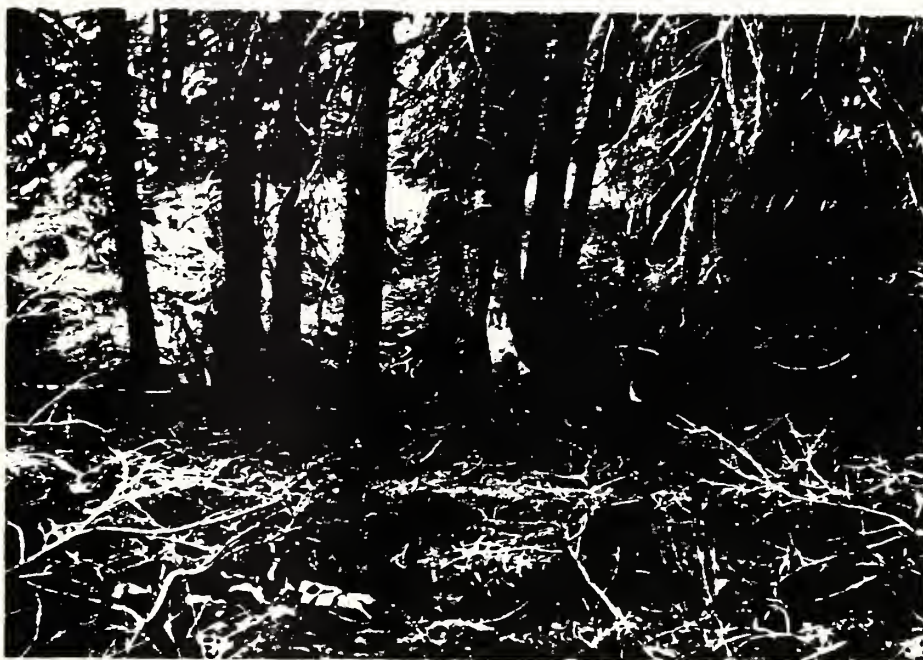
Figure 18. Tree bark along the bases of several trees was probably removed by a previous debris-flow event. Trees are located in bowl to the east of the source area of the Pyramid Guard Station landslide.

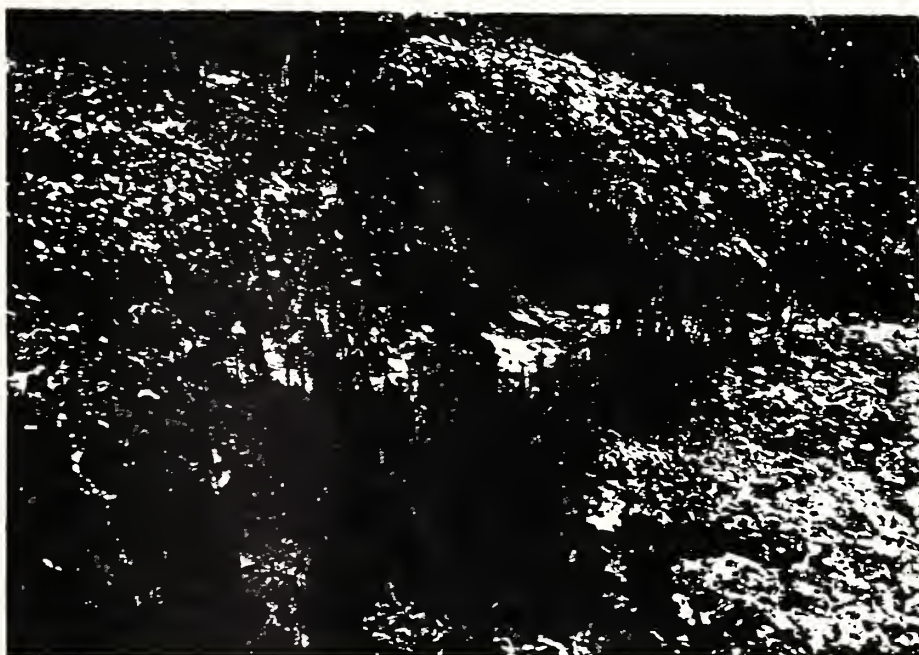
Figure 23. Aerial photograph of the Pyramid Guard Station landslide source area. Darker-colored soil material is evident in the source scar of the initial failure covered by tree shadows. Lighter-colored colluvial and bedrock materials are evident in the source scar of the secondary failure towards the bottom center of the photo.

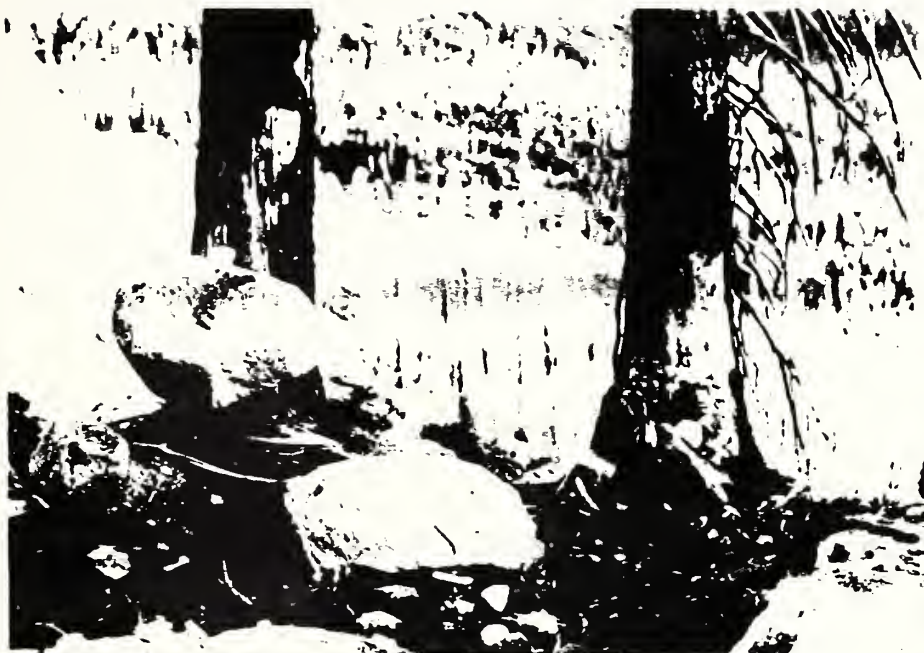
Figure 24. Bark removed from trees located just below the toe of the rupture surface of the Pyramid Guard Station landslide. The bedrock boulder adjacent to the tree has been transported by the debris flow. Day pack 18 inches tall.

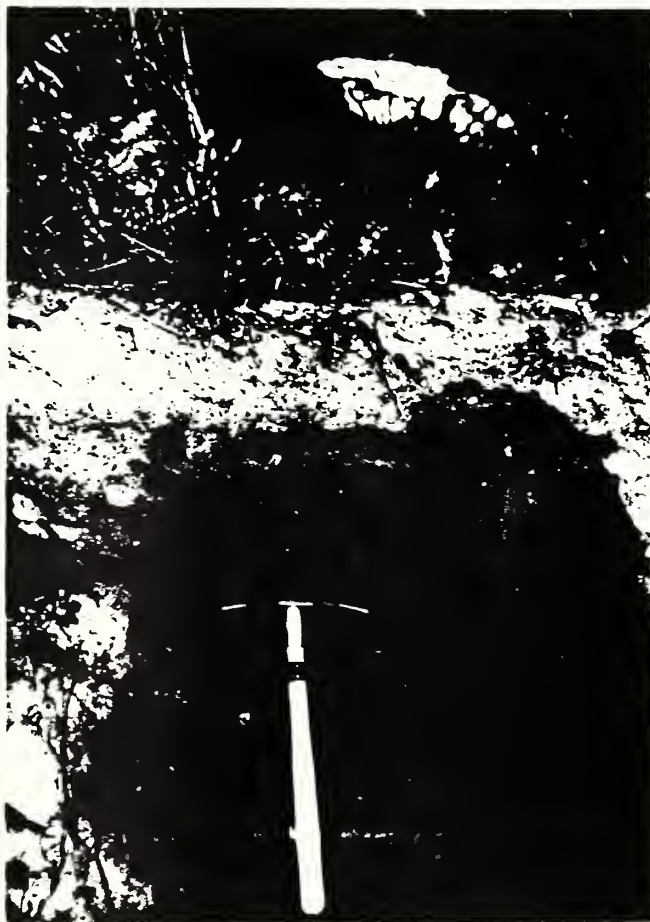
Figure 25. Exposure of undifferentiated debris-flow deposit on topsoil material located upslope from U.S. Highway 50.

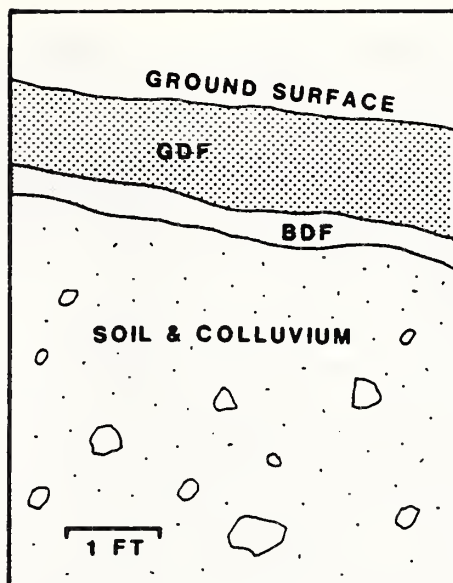
Figure 27. Cross-sectional sketch of wall of pit located below Pyramid Guard Station landslide source area. Gray debris-flow deposit overlies brown debris-flow deposit. The landslide deposits are underlain by topsoil and colluvium.

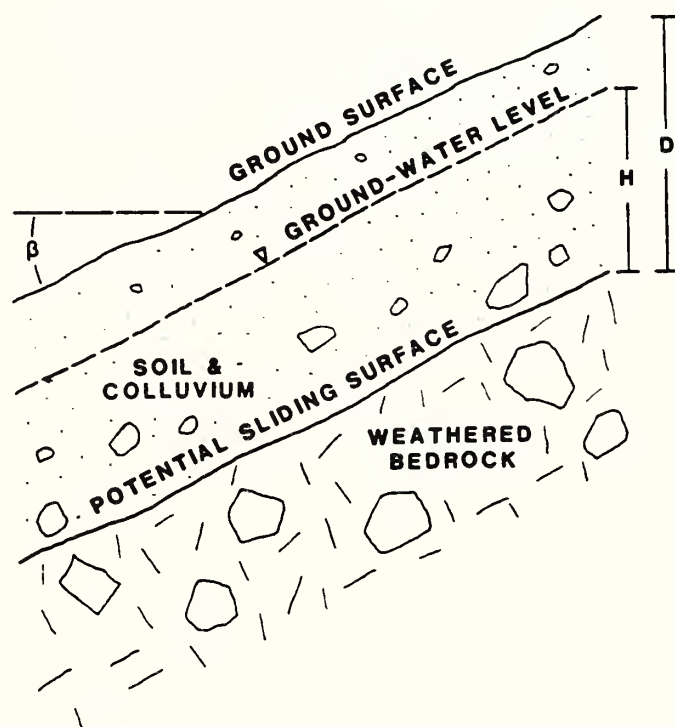
Figure 30) Diagram showing idealized cross-section of subsurface materials prior to soil slip (after Campbell, 1975).

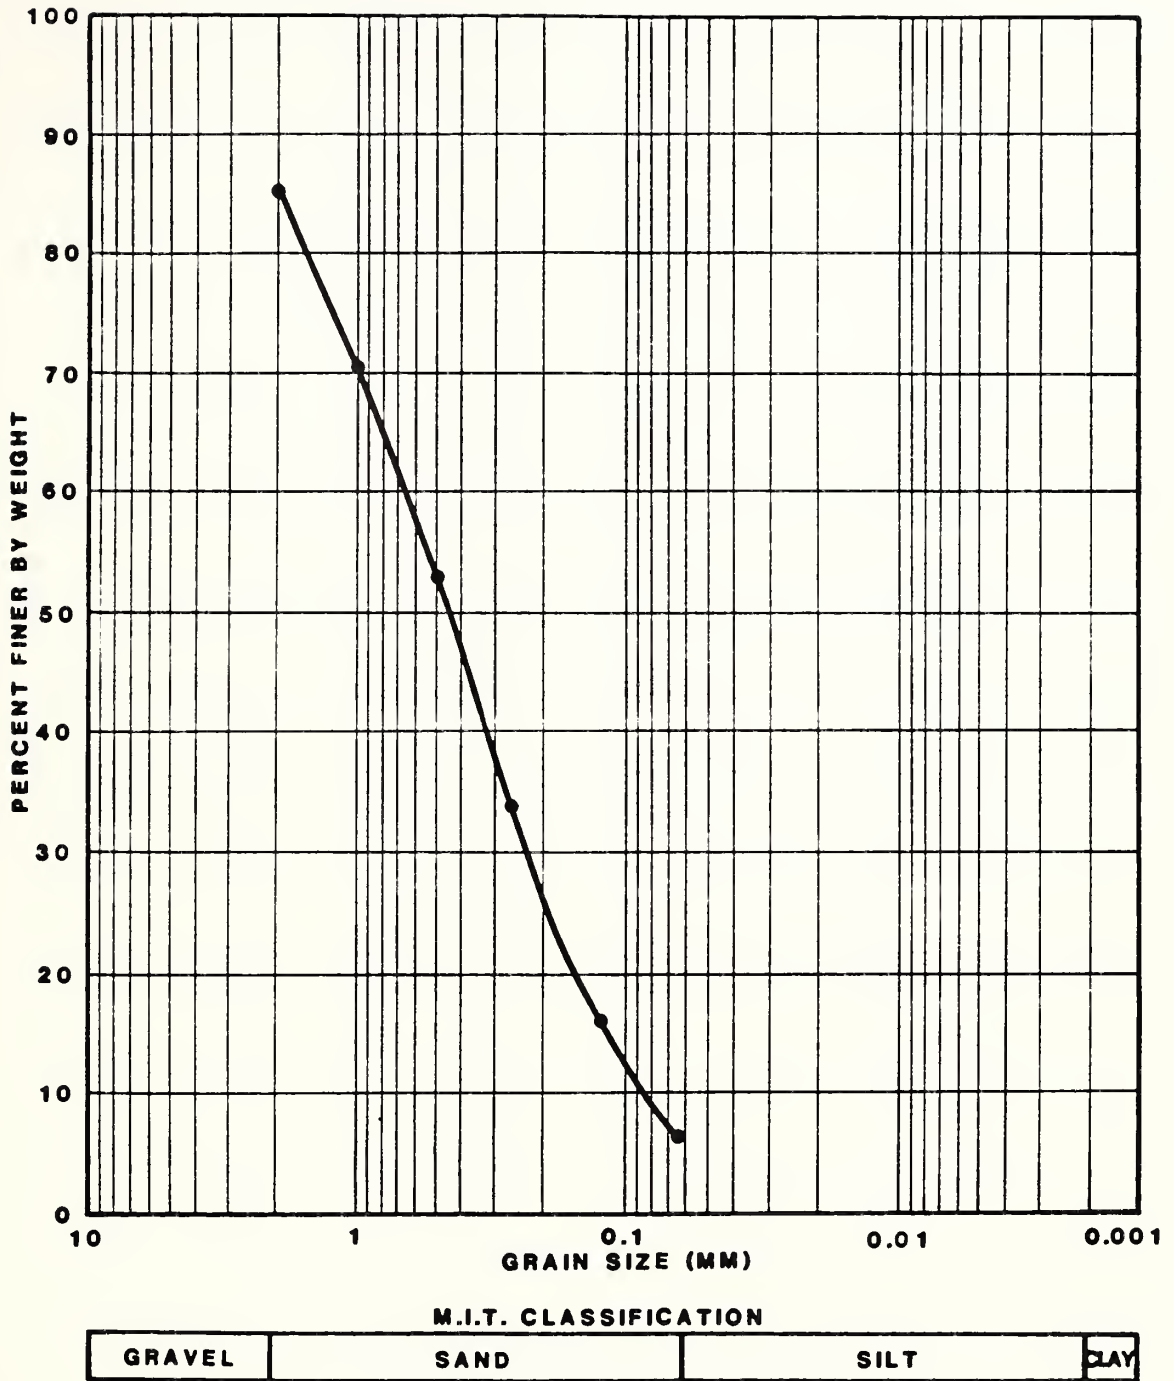
Graph 1. Strawberry Creek landslide sample 1: Ledford-Notned outcrop complex soil (points indicate sieve size openings).

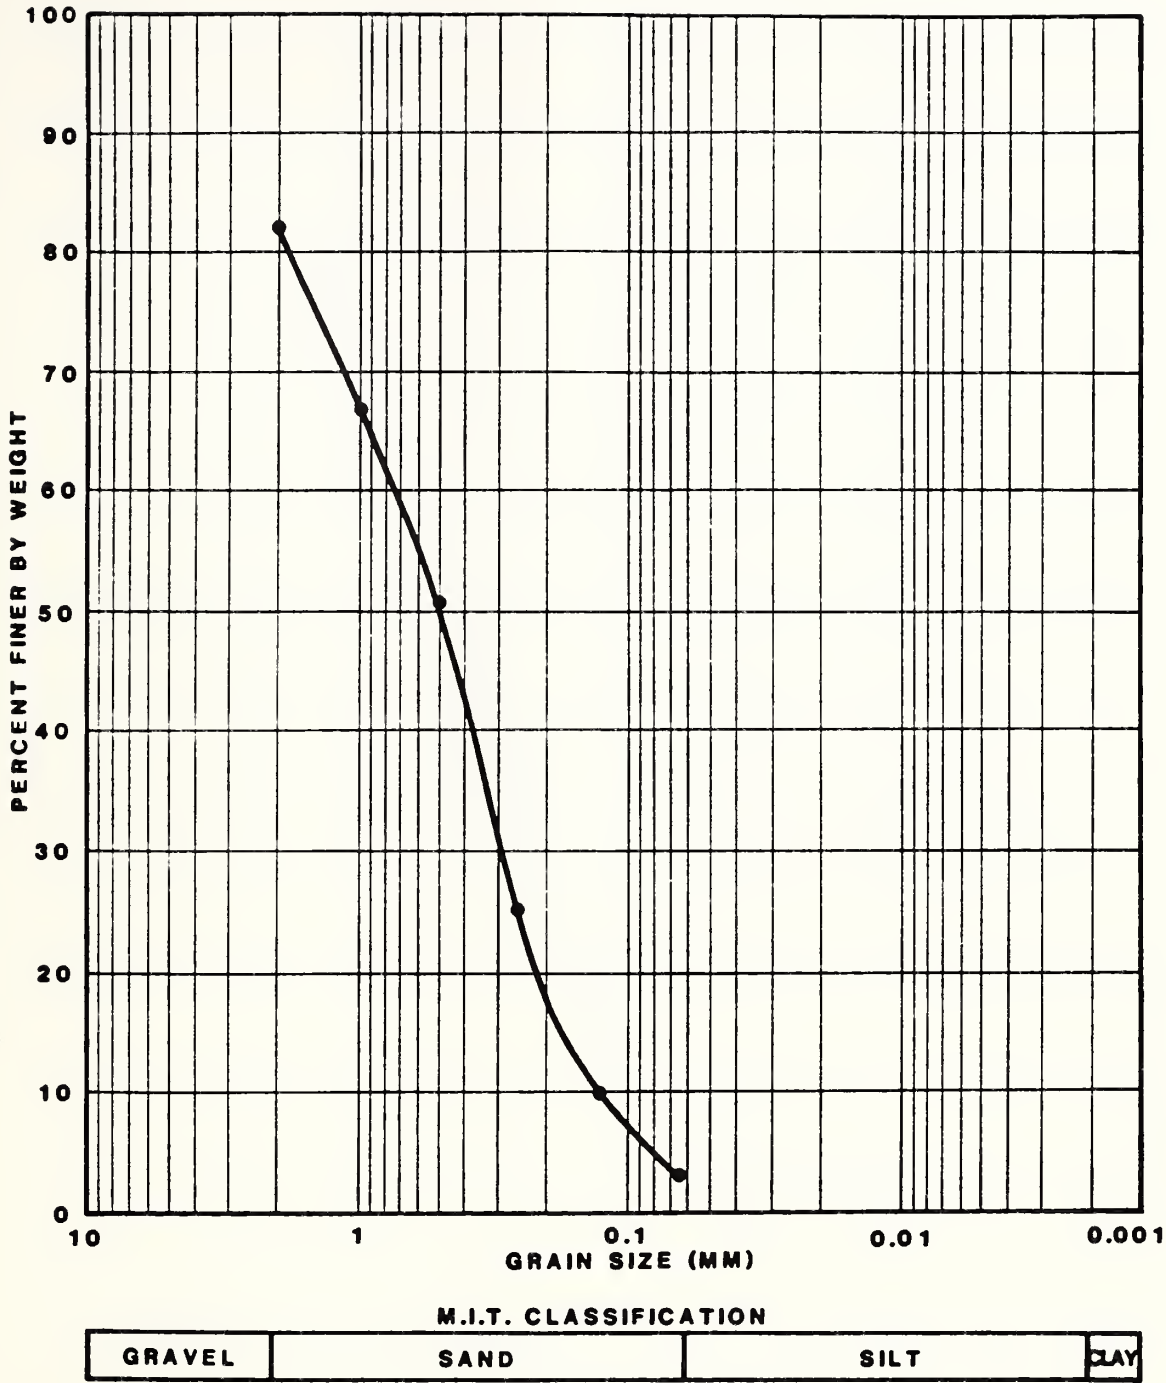
Graph 2. Strawberry Creek landslide sample 9: Lithic Xerumbrepts-Rock outcrop complex soil (points indicate sieve size openings).

presented in Appendix B, Graph 2. The Lithic Xerumbrepts soils are shallow with hard rock typically occurring at depths ranging between 10 and 20 inches. The soils are excessively drained, the permeability of the soil is very rapid, and the maximum erosion hazard of the soil is very high. Runoff within rock outcrop areas is very high.

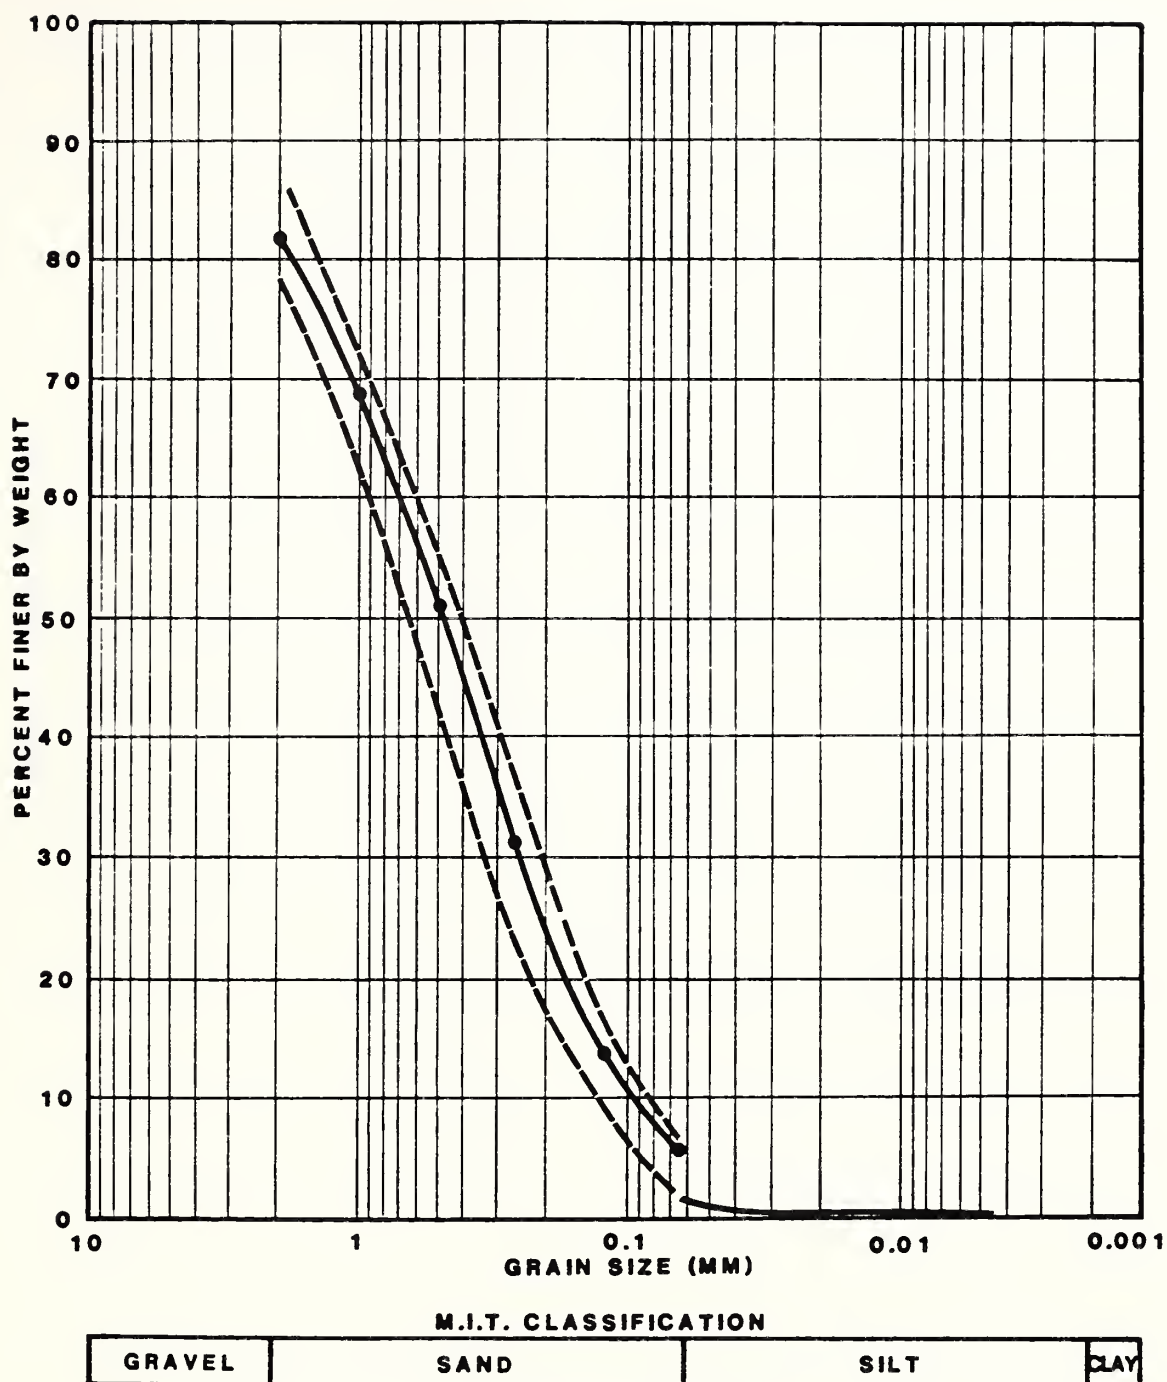
Graph 3. Strawberry Creek landslide: brown debris-flow deposit (points indicate sieve size openings, solid line indicates average curve, dashed lines indicate range, hydrometer analysis shown as solid line).

The brown debris-flow deposit is clearly associated with the initial failure of the Strawberry Creek landslide that occurred within the relatively deep soils of the Ledford-Notned complex soil unit. In-situ Ledford-Notned complex soil, sample 1, was collected from the location shown on Plate 1 at an elevation of 6,370 feet. A grain size distribution curve determined from sample 1 (Graph 1) falls within the range of grain size distributions for the brown debris-flow deposit shown on Graph 3.

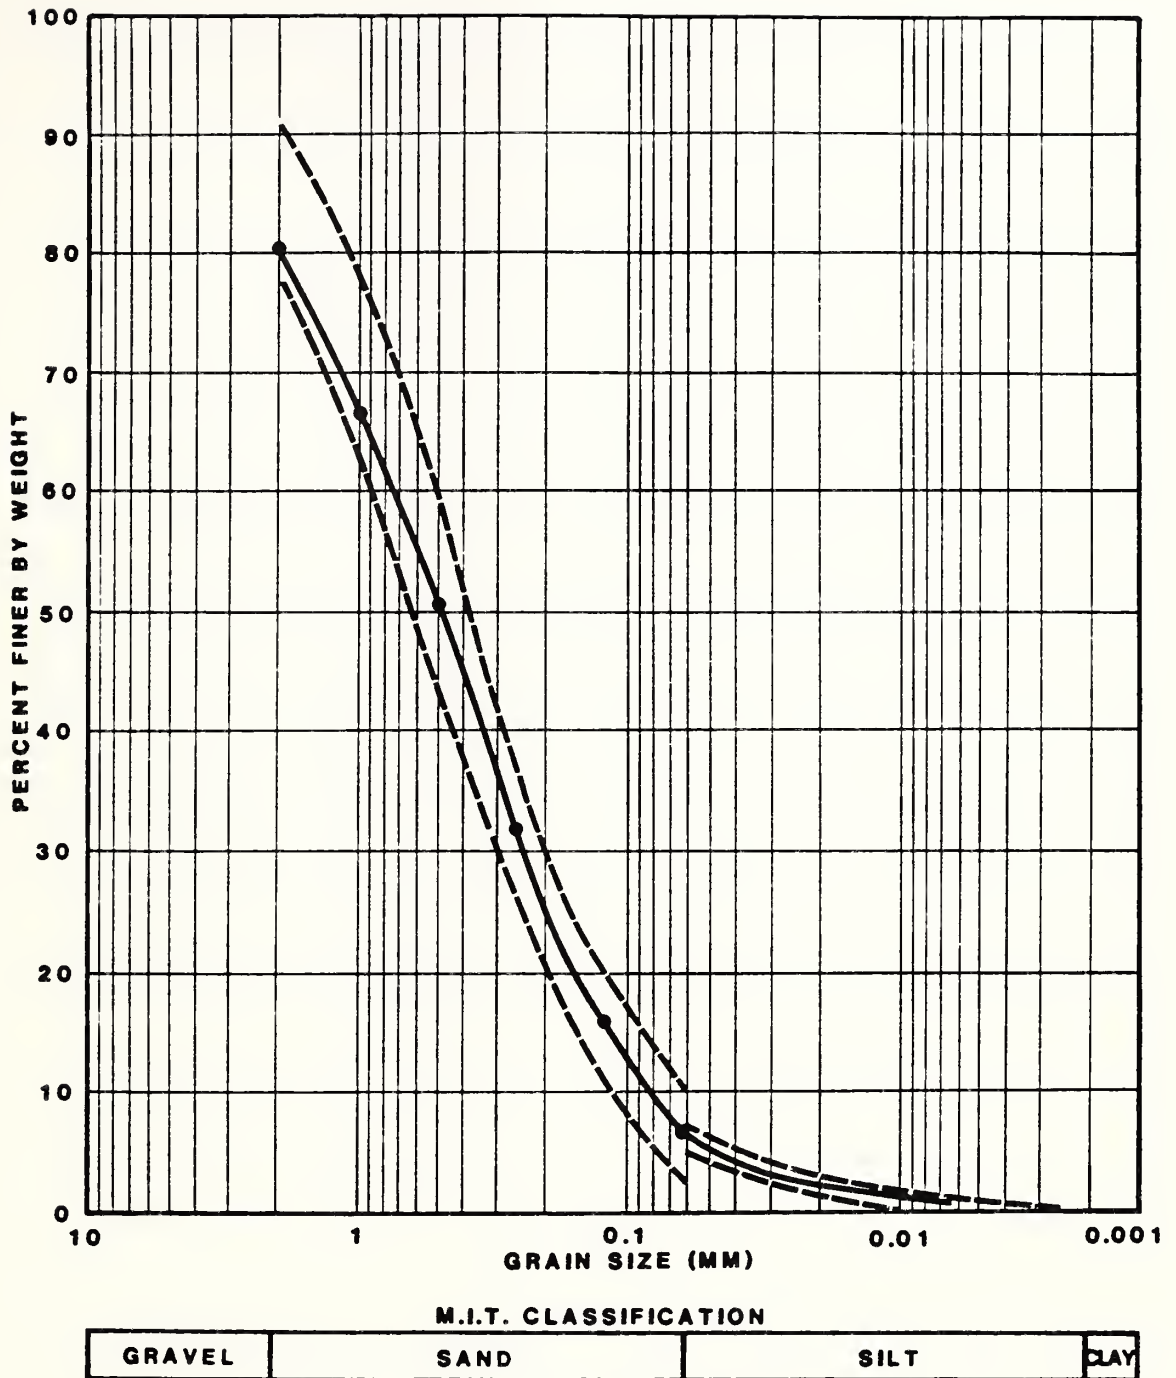
Graph 4. Strawberry Creek landslide: gray debris-flow deposit (points indicate sieve size openings, solid line indicates average curve, dashed lines indicate range, average hydrometer analysis shown as solid line with range as dashed lines).

The gray debris-flow deposit is clearly associated with the secondary and tertiary failures of the Strawberry Creek landslide that occurred within the relatively shallow soils of the Lithic Xerumbrepts-Rock outcrop complex soil unit. Sample 9, of in-situ Lithic Xerumbrepts-Rock outcrop complex soil, was collected from the location shown on Plate 1 above the landslide headscarp. A grain size distribution curve determined from sample 9 (Graph 2) falls within the range of grain size distributions for the gray debris-flow deposit, shown on Graph 4.

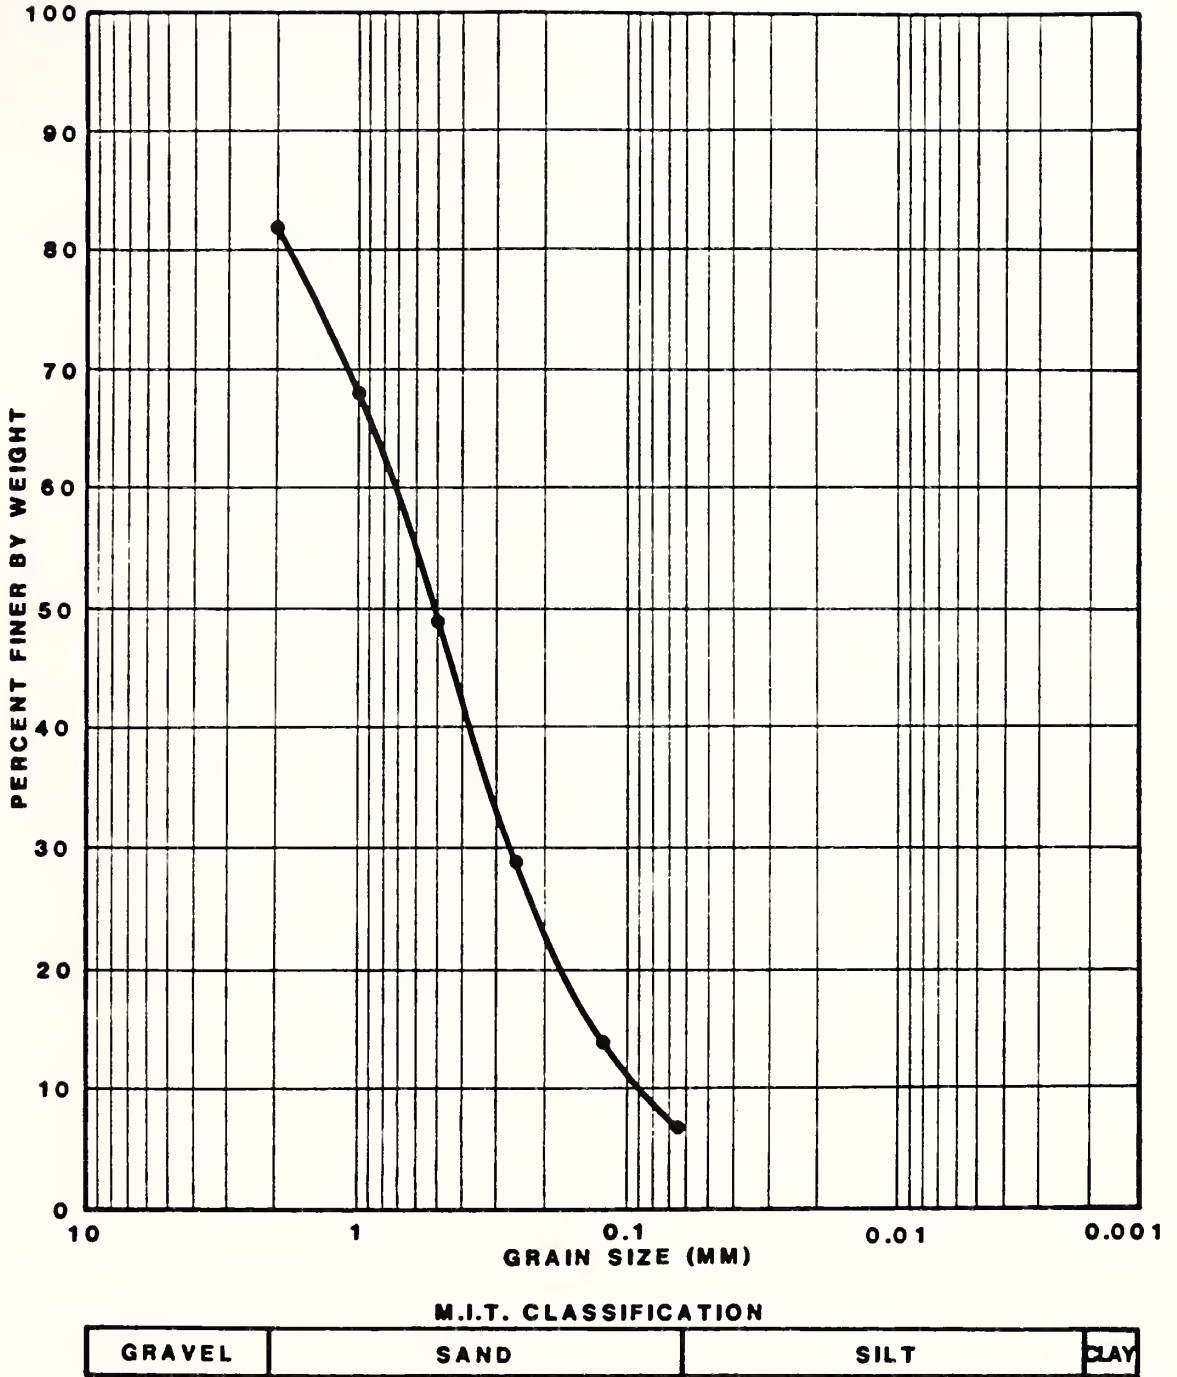
Graph 5. Pyramid Guard Station landslide sample 1: Lithic Xerumbrepts-Rock outcrop complex soil (points indicate sieve size openings).
